Zero-exchange demonstration posts good results in Nicaragua

Prototype system proved to be biosecure against WSSV

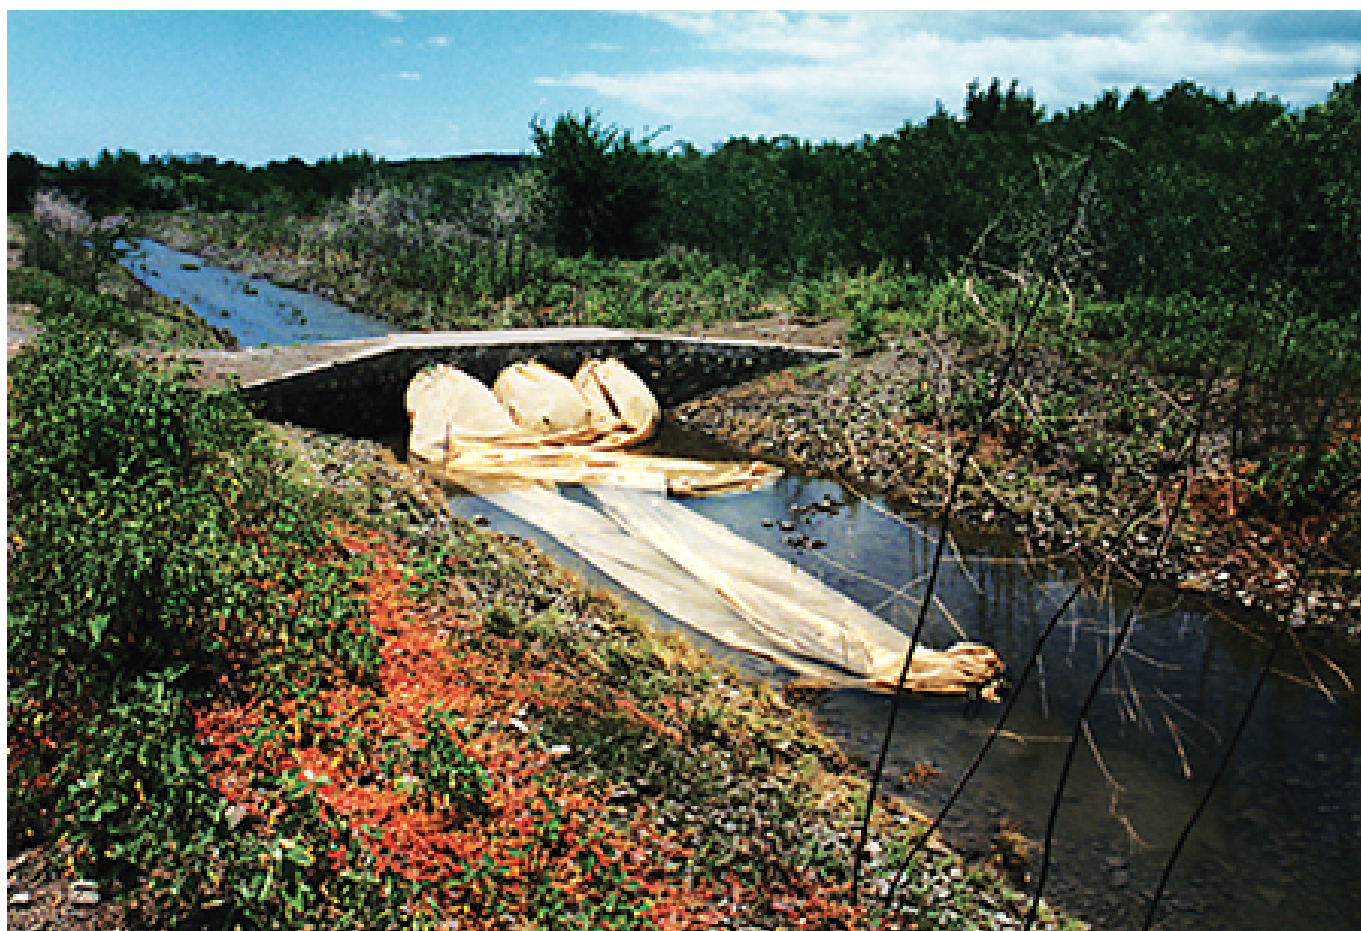
Incoming water flowed through a series of filters to eliminate hosts that could harbor shrimp viruses.
Photo by Russ Allen, Michigan Sea Grant.

Water introduced into the system flowed through a series of filters to eliminate hosts that could harbor shrimp viruses. Water from the Estero Real was passed through a 500- μ filter into the receiving and distribution canal and settling ponds. From the settling ponds, water was filtered at 300 μ into a secondary reservoir and then at 200 μ into a tertiary reservoir. Finally, water entered the grow-out ponds through a 100- μ filter.

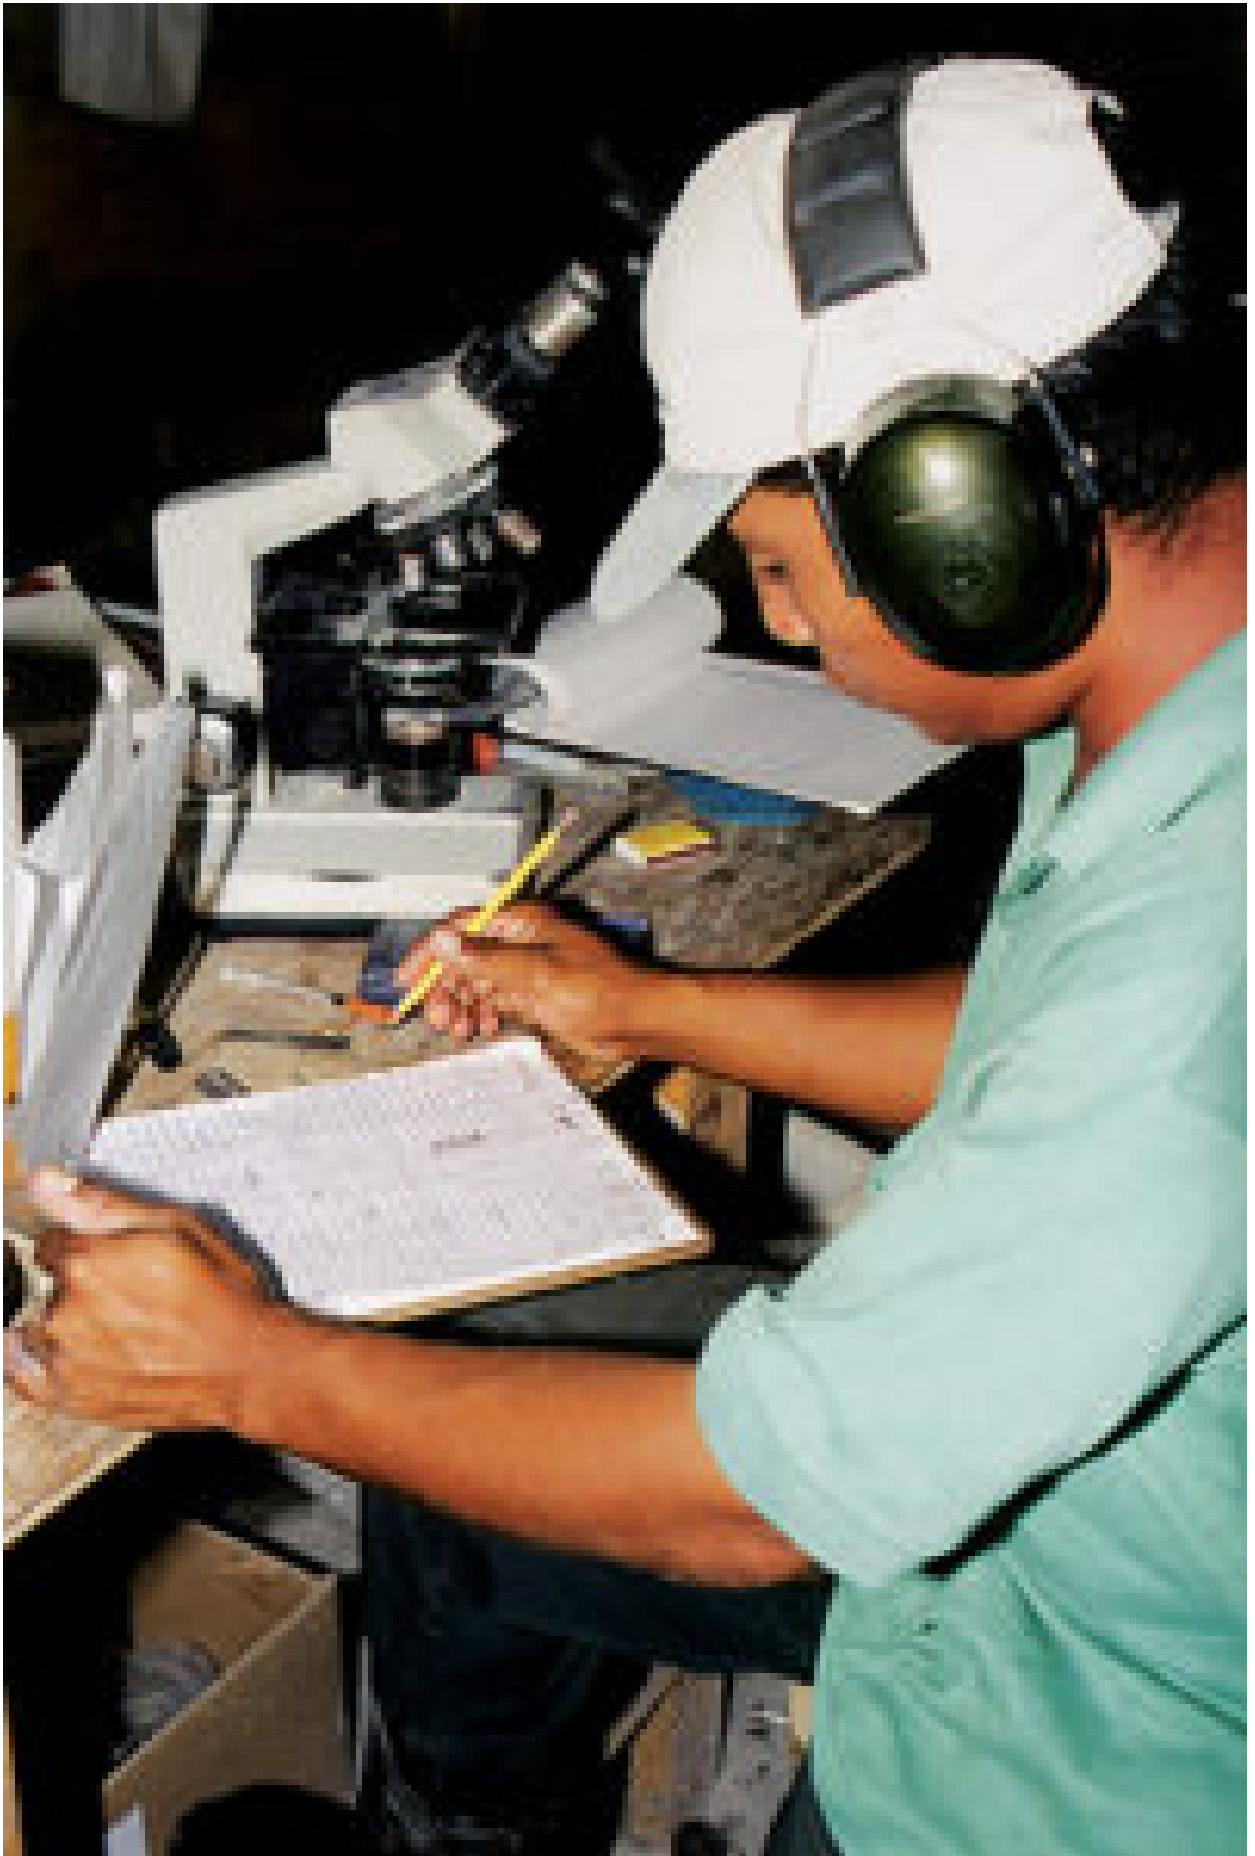
Chemical parameters in ponds were measured weekly. Photo by Liz Light, Michigan Sea Grant.

Chemical parameters were measured at least once a week. Alkalinity was increased by adding agricultural lime to ponds. Ammonia-nitrogen levels ranged from below 0.01 milligram per liter to 3.5 milligram per liter (typically around 0.5-milligram per liter). Nitrite and nitrate were normally below 0.2 milligram per liter.
